The Huge Importance of Inspecting and Diagnosing a Building for a Sustainable Rehabilitation Project

Bruno Miguel Fradigano Nunes; Dulce Franco Henriques

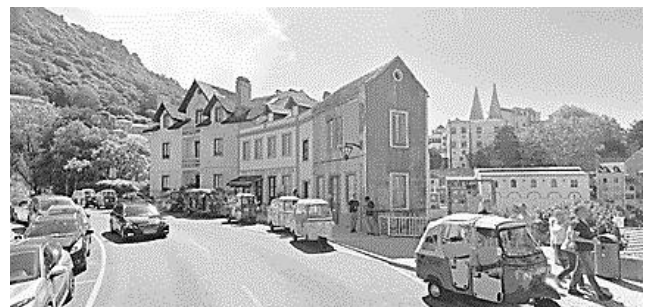
Fig. 1. The building (in the center) and its surroundings.

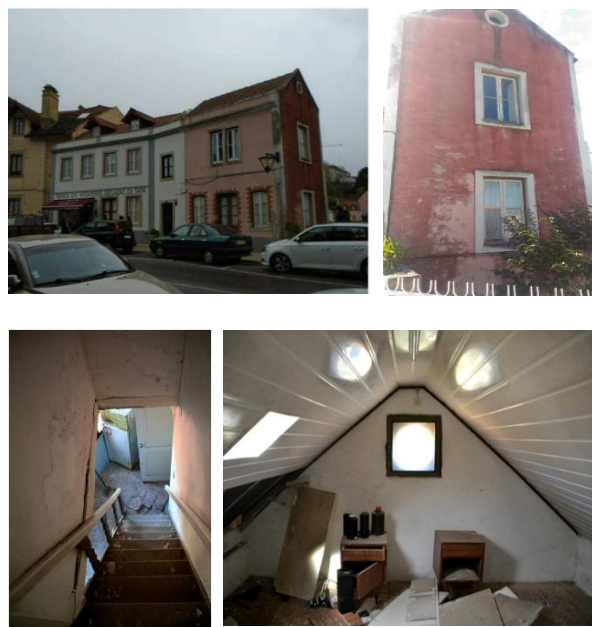
The thickness of the attic slab is 10cm, which makes it difficult to decide on its design. The construction of two 1.10 m x 1.30m mansards on the roof, given their proximity to each other (approx. 0.60 m) could lead to a solution using metal profiles and not wood as initially thought, to withstand the stresses caused by wind and weather. water table, which causes it to receive vertical loads in an upward direction due to hydrostatic thrust (Fig. 2) [12], [17].

The plaster on the walls has anomalies, with occasional detachments. One of the possible causes could be infiltration and the cycles of air humidity in the winter and drying in the summer, stiffening the base of the plaster and causing it to detach (Fig 2).

Fig. 2. The building (in the center) and its surroundings.

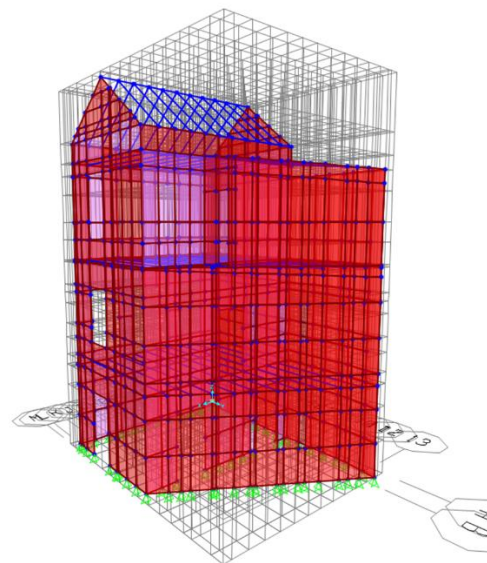
Fig. 3. structural model in the SAP2000v16 program.
