Chaby building – Inspection, Rehabilitation, and Maintenance

Abstract— A study was carried out on the Chaby building, involving inspection, rehabilitation, and maintenance of the most critical areas of the house and common parts of the building, taking into account the criteria implemented in the “Method for the Evaluation of the Conservation State of Buildings” (MAEC), developed by LNEC (National Laboratory of Civil Engineering). The objective of this work is to identify the deteriorations of the Chaby building by conducting a visual survey, describing the anomalies and their possible causes. After that, a rehabilitation and maintenance plan is developed to address the problems found in the residential and common areas of the building. The rehabilitation plan consists of a set of efficient solutions for the respective anomalies. As for the maintenance plan, its main objective is to preserve the building after its rehabilitation.

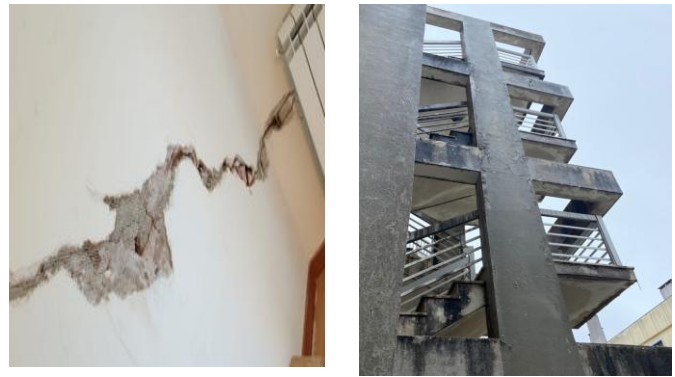
Fig. 2 Anomalies of the building

A chapter is dedicated to describing the visual inspection carried out on the building, considering all the factors imposed by LNEC for assessing anomalies in the functional elements of the structure (Fig. 2)

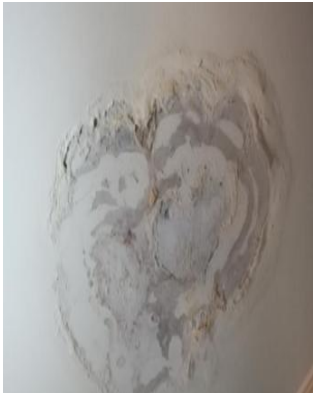
Efflorescence and detachments

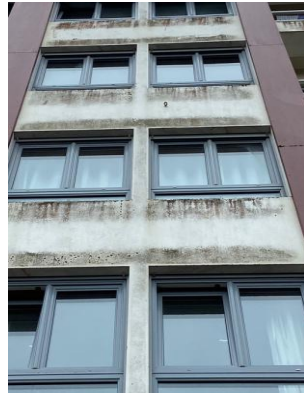
Dark stains

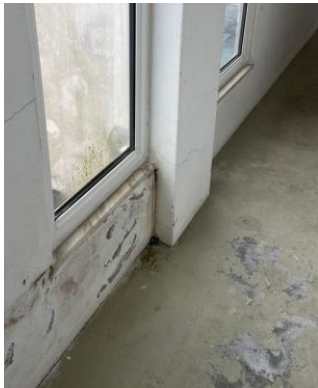
Green Stains and efflorescence

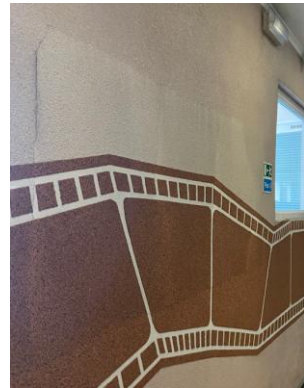
Plaster Detachment

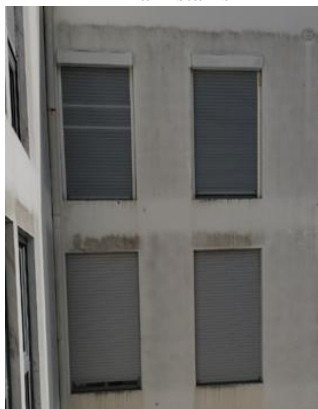
Dark stains

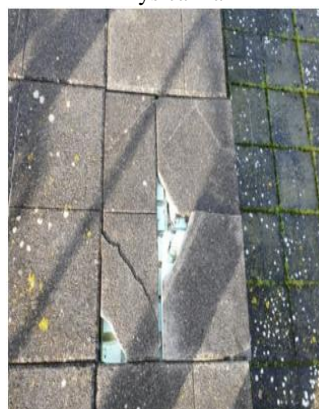
Physical harm
